## 服务报告 Service Report

M/V Talbot

KongSberg ACC20

- ME Servo motor replacement and commissioning

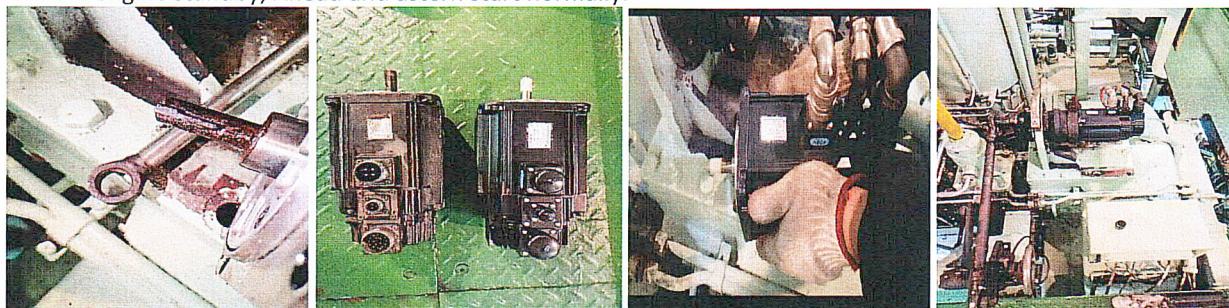
Visual and inspect the servo motor, found that in the idle mode the motor is running, the internal noise is too large, especially at the encoder end. At the same time, the key pin is broken already. After confirming with C/E and 2/E on site, Our company suggestion is recommended to replace servo motor immediately. At the same time, feedback site situation to company and shipowner, later, after the shipowner agreed to replace it, the new spare parts were installed and the commissioning operation was normal.

Main engine standby, Ahead and astern start normally.

Regular check of running sound and gearbox
